TECHNICAL REPORT S-70-9

STUDY OF CLAY SHALE SLOPES ALONG THE PANAMA CANAL

A REANALYSIS OF THE EAST CULEBRA SLIDE PANAMA CANAL

August 1978

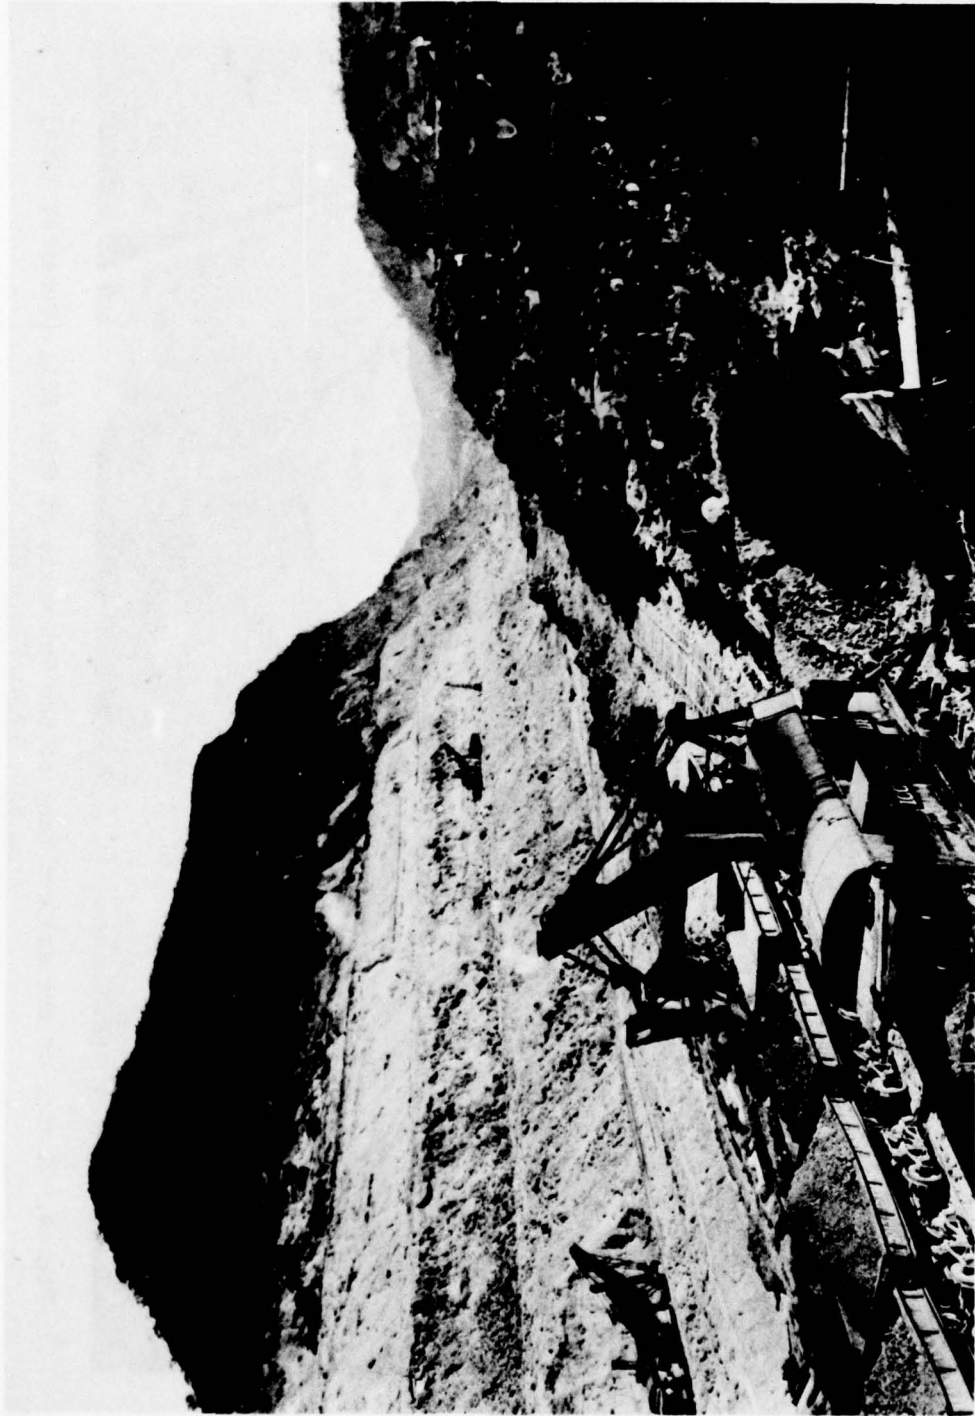
Fig. 5. A view of the eastern bank of the Cut north of Gold Hill (February 1907)
(from National Archives Files)

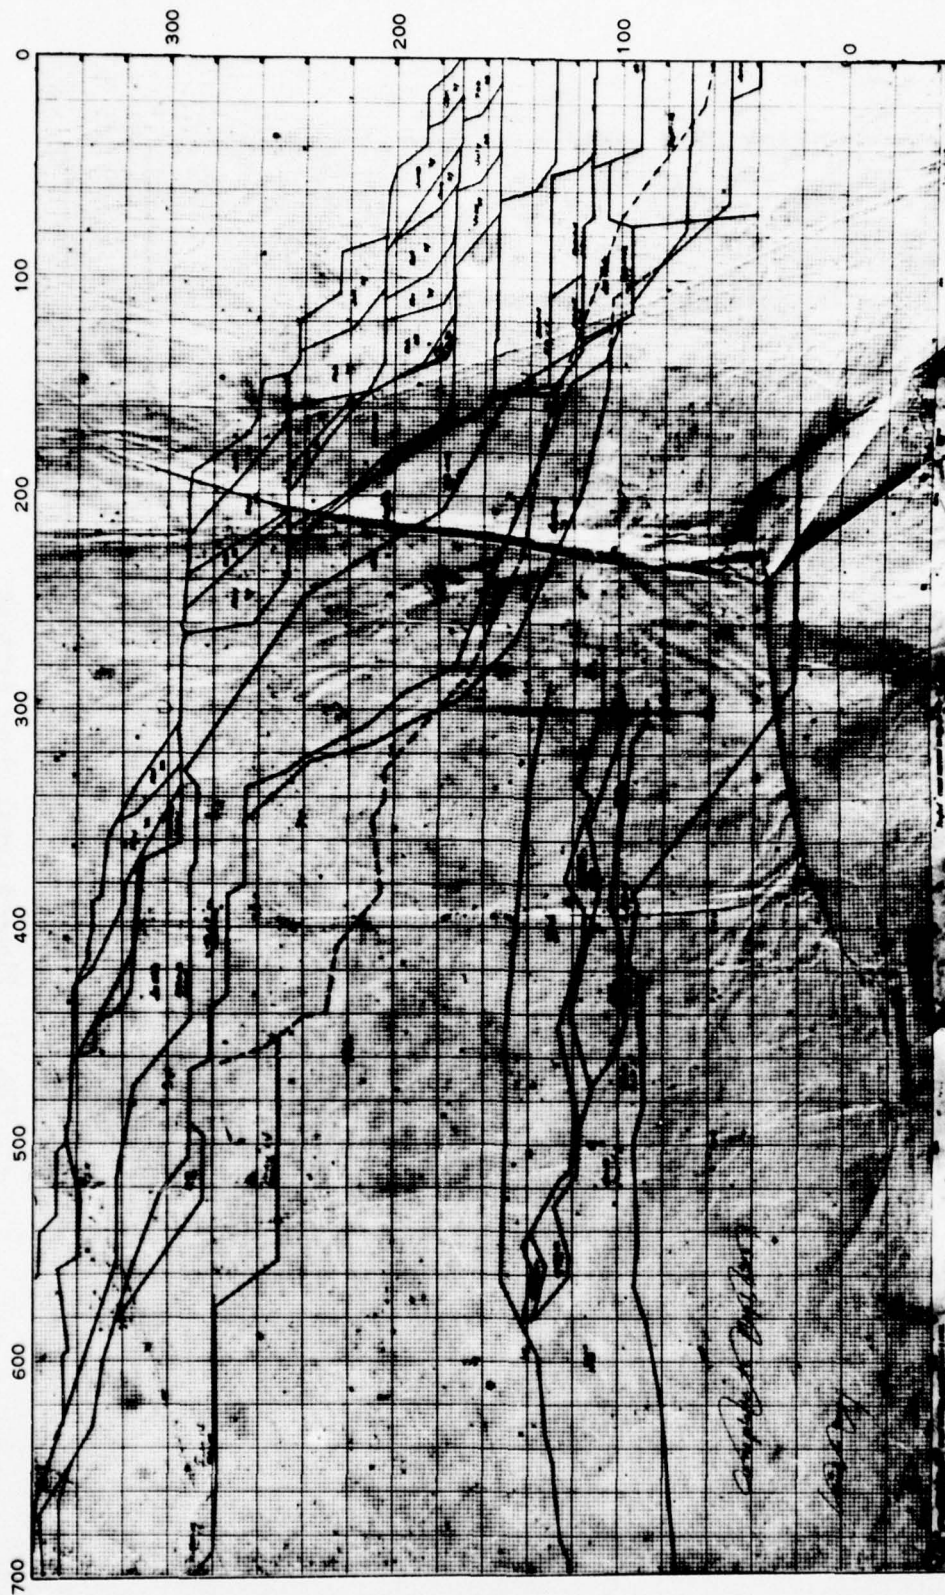
Fig. 6. Construction cross section at sta 1952+60 (1785+00)
(from PCC Vault File 288)

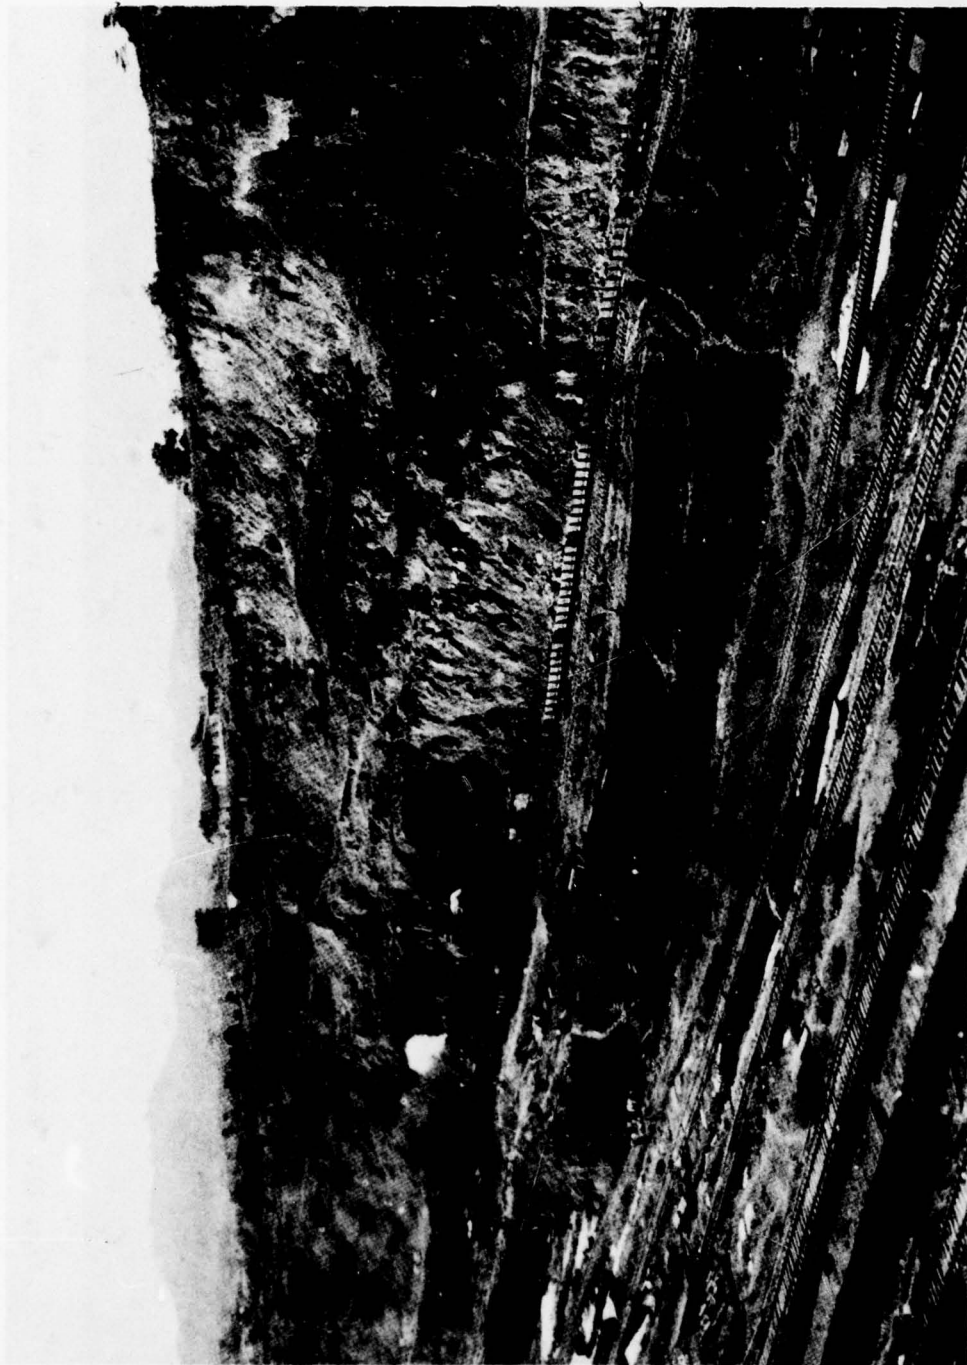
Fig. 10. A slide on the east bank of the Cut opposite Culebra (June 1910)
(from NAS, 1924; Plate 28)

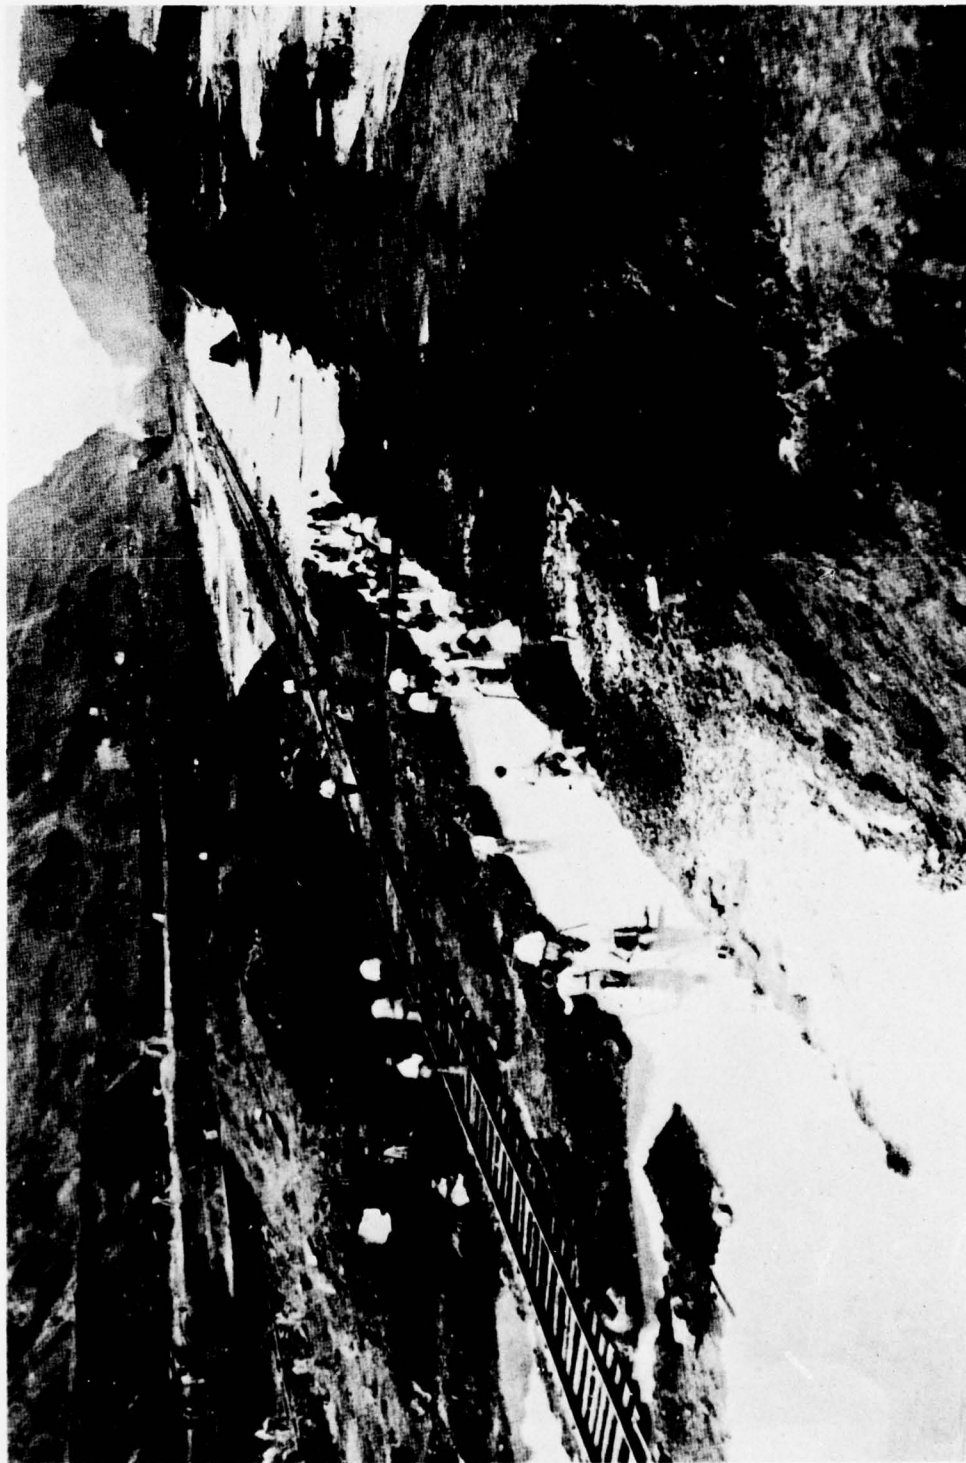
Fig. 11. A mound of upheaval, 18 ft in height, in the floor of the Cut, north of Gold Hill (1910) (from NAS, 1924; Plate 29)

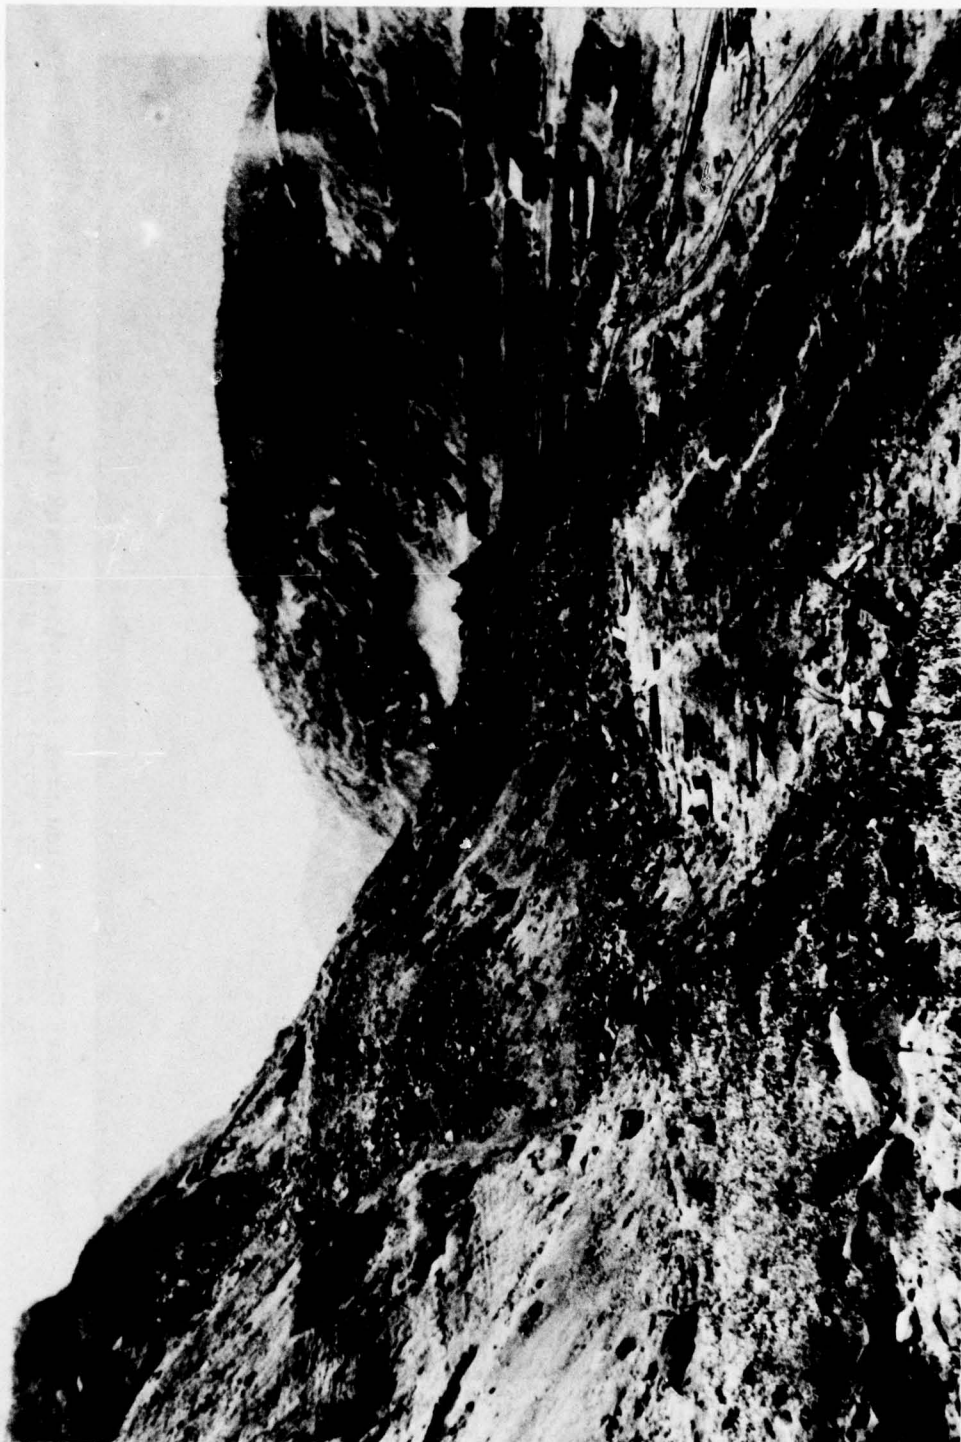
Fig. 12. Break in east bank opposite Culebra, view to the south (February 1912)
(from National Archives Files)
